| <b>Site</b> | Packaging Hall |
| <b>Job</b> | J-1042 Divert valve seal change, annual shutdown |
| <b>Asset</b> | DV-106 Divert valve DN80 |

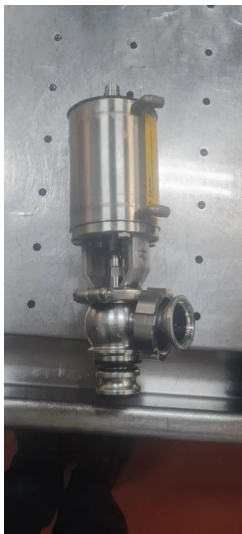
Hairline crack in the valve housing at the lower port weld. Product weeping under line pressure. The valve cannot go back into service as is.

Cut out the cracked DV-106 housing, fit a new DN80 housing and weld it into the line. Pressure test, passivate, rebuild the valve with new seals and function test with the site before restart.
